The Locomotive

THE HARTFORD STEAM BOILER
INSPECTION AND INSURANCE CO.

VOL. XL

1934-1935

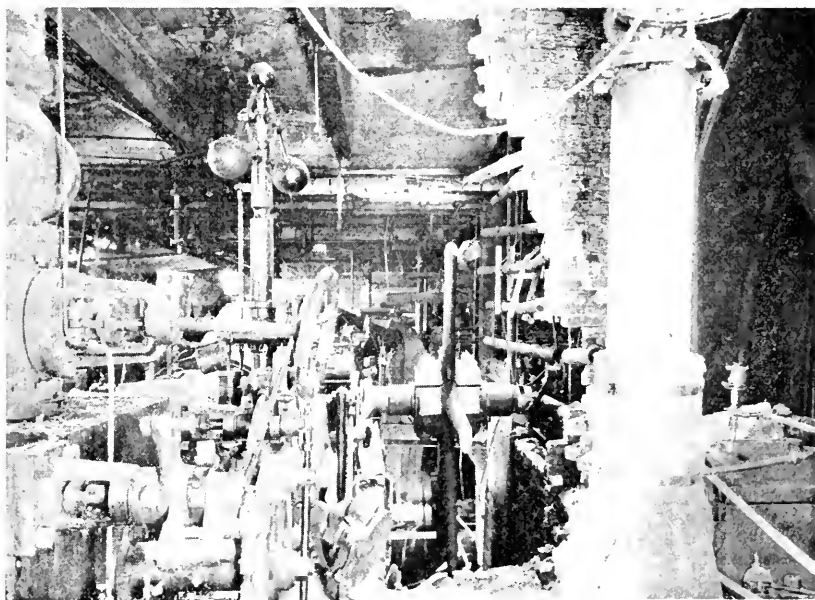
When water sprayed on the governor belt of a steam engine used by an Ohio paper board manufacturer, the belt slipped, allowed the engine to overspeed, and the flywheel exploded. The leakage of water was from an overhead sprinkler system which was damaged after a series of events that started with the breaking of a belt on a 500 hp motor. This belt whipped loose a guard rail and hurled it into the belt of the main engine. Either the flying guard rail or the motor belt struck and severed the sprinkler pipes.

It was noted after the accident that the wires for the overspeed stop were torn down, and it was considered possible that these wires were broken by the belt which broke on the motor. This, of course, would account for the failure of the overspeed stop to operate.

The entire rim of the flywheel broke loose from the spokes and flew in pieces into other parts of the building. The engine itself was badly wrecked. One piece of the wheel weighing 1980 lb struck the jordan (a machine for slashing the pulp before it passes into the paper

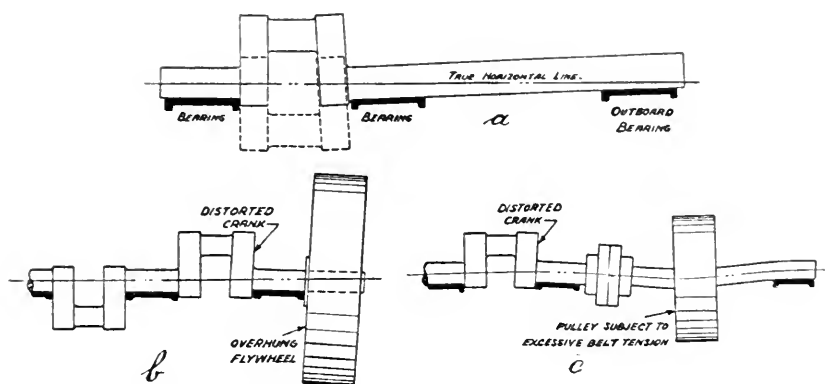
FIGURE 2—Crank distortions (exaggerated for purposes of illustration).

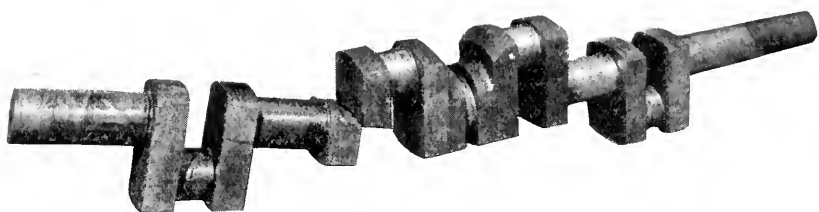
FIGURE 5—*The result of serious over-stresses in a crankshaft caused by bearing wear.*

considerably. Figure 4 shows how the gage is used between the webs of a Diesel crankshaft. The broken shaft shown in Figure 5 shows the baneful result of serious crank distortion caused by worn bearings.

By the regular periodic application of the Straingage to any center-crankshaft it is possible to prolong the useful life of the shaft very

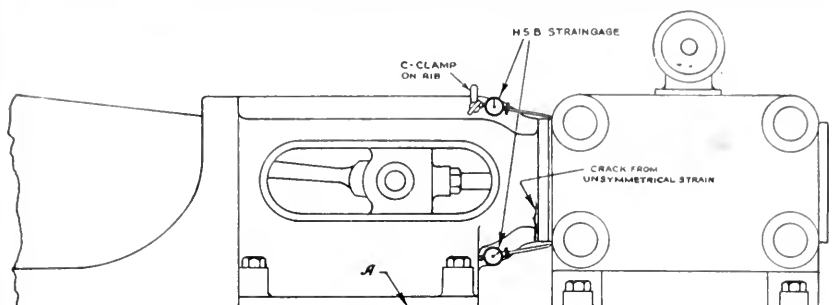
FIGURE 6.

Another useful application of the gage is the measuring of unsymmetrical strains caused by misalignment in the frame neck of horizontal engines. For this purpose the gage is applied as shown in Figure 6. While the engine is operating under a load, comparison of the readings taken in the upper position with the readings taken in the lower position gives a very definite idea as to whether the frame neck is subject to over stresses which would eventually lead to cracks. If, for example, a top reading is 2 mils and the bottom reading is 4 mils, it is evident that the frame neck is being bent at every revolution of the engine and that an undue amount of stress occurs at the bottom of the frame neck.

The misalignment that causes the overstress which results in cracking the frame neck, is generally due to softening of the grouting by lubricating oil at "A", Figure 6. In any installation where lubricating oil is allowed to run down the sides of the engine frame and to soak into the foundation, it is certain that serious misalignment will eventually result because concrete and brick become quite soft and compressible when saturated with oil. After some years of operation under these conditions it becomes noticeable that oil is pressed out from under the frame at point "A" when the crosshead moves over that end of the guide barrel, and the oil is drawn in again as the crosshead moves to the crank end. When this occurs it is clear that the engine frame is not being properly supported at point "A" because the grouting has become soft and compressed. The consequence is that the downward force of the crosshead, acting on the guide barrel, is transferred through the frame neck to the nearest support under the cylinder which produces a bending action in the frame neck that is almost certain to result in a cracked casting. An example of the results of unsymmetrical strain in the frame neck is shown in Figure 7.

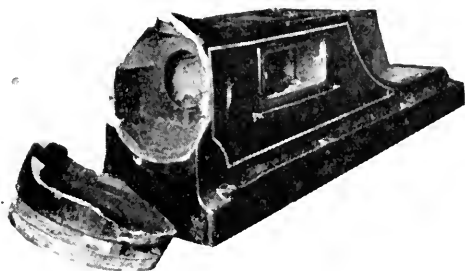
FIGURE 7—Result of crack in engine frame neck caused by unsymmetrical strain.

The vertical movement of the frame at the point where the grouting has become compressed has given some operators the erroneous impression that the nut of the nearest foundation bolt had worked loose. Tightening of the foundation bolt nut under such circumstances, while the engine was running, put such a severe bending stress in the frame neck in a few cases that it was only a matter of minutes before a long crack had formed. The tightening of foundation bolts of engines should never be undertaken without first carefully analyzing the real cause of the looseness of the bolts. The looseness as pointed out in the foregoing, may be the result of the softening of the grouting. If so, a re-aligning of the castings on the foundation and regrouting is necessary before the foundation bolts can be properly tightened.

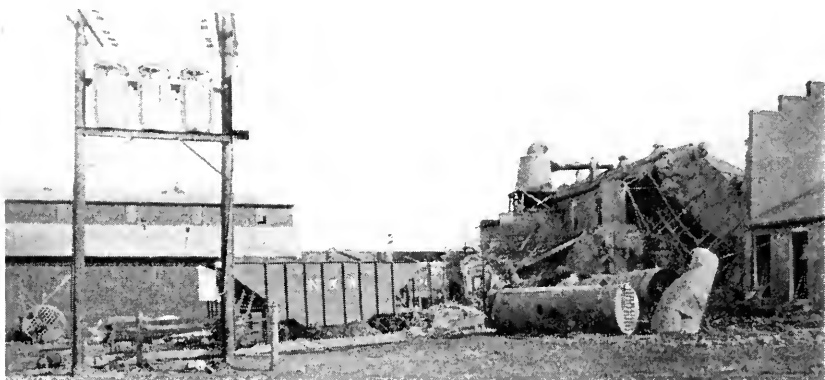
The rear course with the rear head attached unrolled and flattened out. It must have traveled in a nearly vertical direction as it soared over the roof of the power house. This part of the exploded boiler, weighing approximately 5 tons, came to rest upon the top of the east wall of the main building 46' above the ground and 100' from its setting. One end of the sheet extended over the wall and the other end pierced the mill building roof and rested on the upper end of the cottonseed elevator.

The steam drum and steam pipe with the throttle valve attached passed over the engine room and landed on a railroad switch track, damaging a cottonseed conveyor in its flight.

The one story brick powerhouse was demolished. Practically one-half of the two story 36' x 120' mill building was knocked down and there was considerable damage to the expensive mill machinery.

Men in the linter room on the second floor of the mill miraculously escaped with nothing more serious than cuts and bruises. The floor on which they were working was raised several feet and then crashed down onto machinery below. One man was buried in the debris but he was able to crawl out. Flying bricks and structural steel did considerable damage to surrounding buildings. An idea of the extent and character of the damage is portrayed in the accompanying photographs.

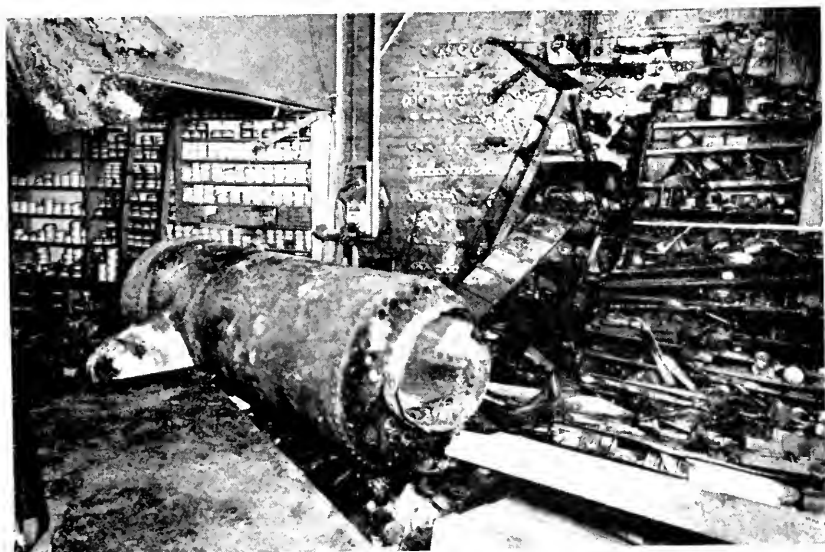
Caused by corrosion and over-pressure.

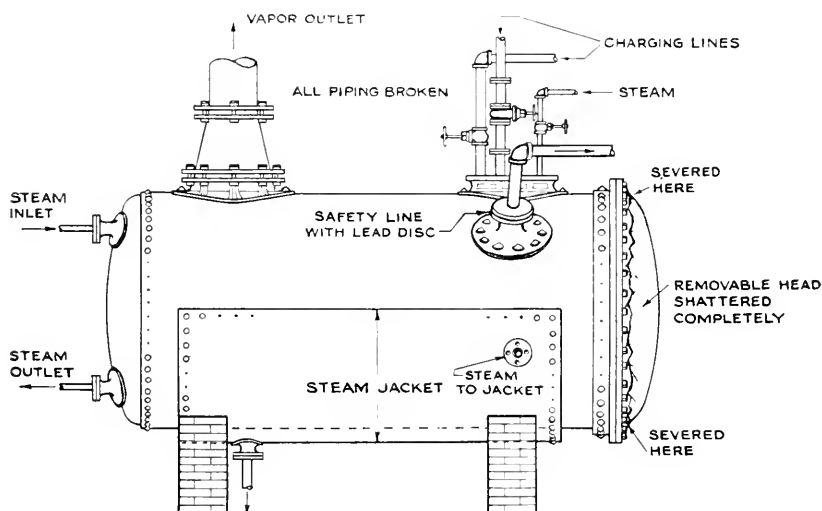
Figure 1—Diagram of still showing steam lines and head which failed.

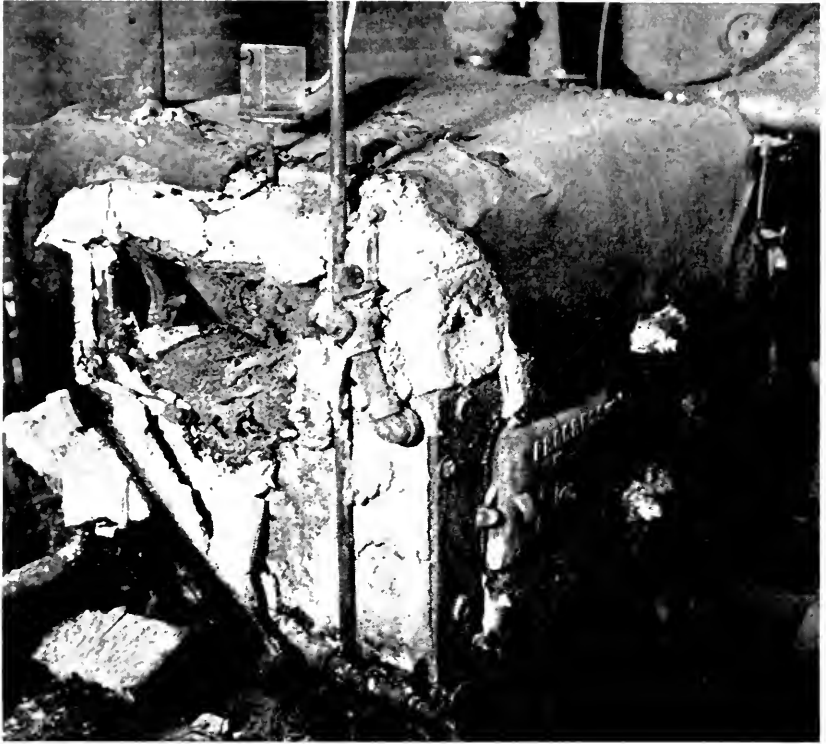
Close-up view of welded seam failure.

examination of the seam showed that the welded joint had pulled apart all the way around the head, which was of the unflanged disc type 48" in diameter with a 3" crown. There was a manhole in the head. The tank was 66" deep from head seam to head seam and at the bottom there was a cone 29" long. All joints were welded. The welding was of the butt type both inside and out. At the time of the accident the tank was being operated at a pressure of 60 lb. The character of the failure is shown by the accompanying photograph. The tank did not conform to A.S.M.E. standards for such vessels, and was not insured.

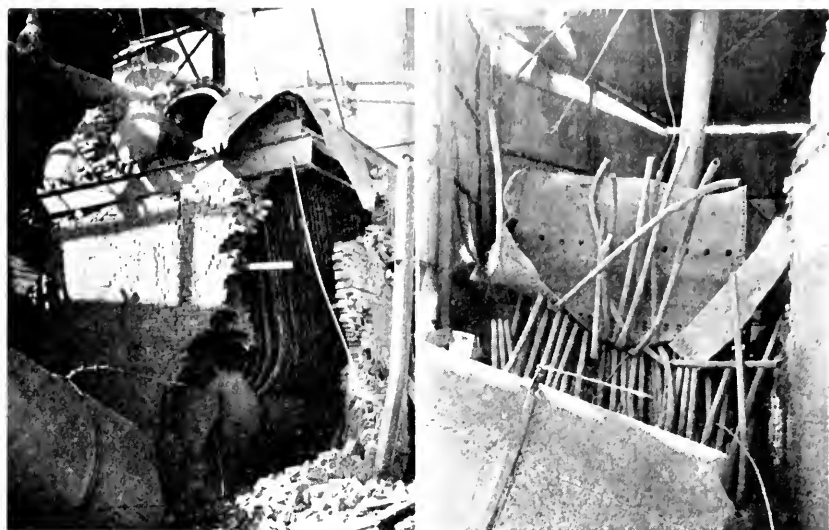
*Part of exploded sawmill boiler
in Georgia forest.*

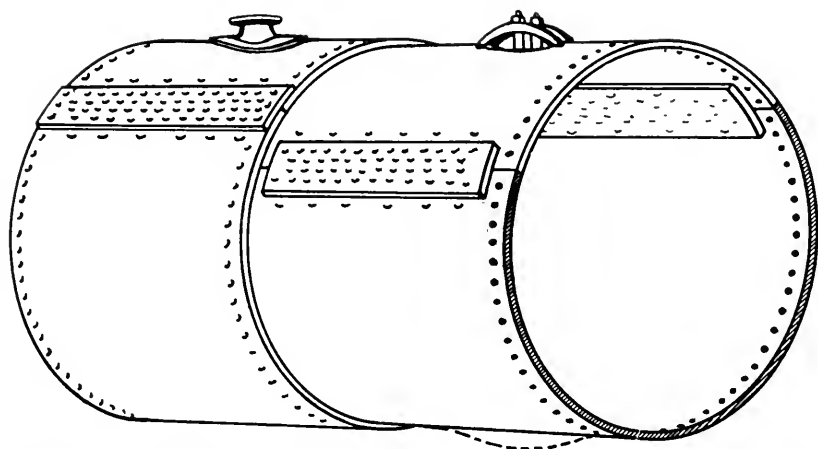
Figure 1—Repair of a bulge caused by overheating because of an oil deposit on the plate.

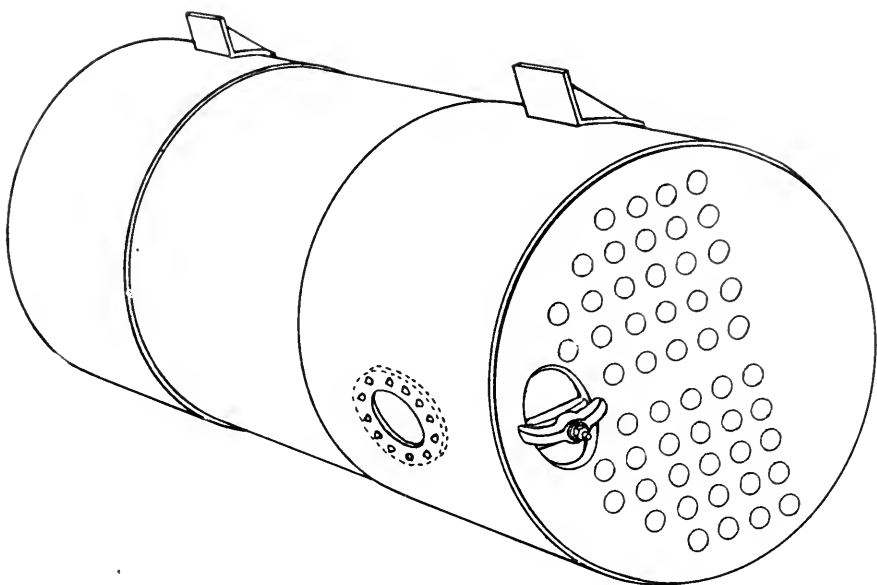
Figure 3—Repair of a bulge caused by overheating because of scale.

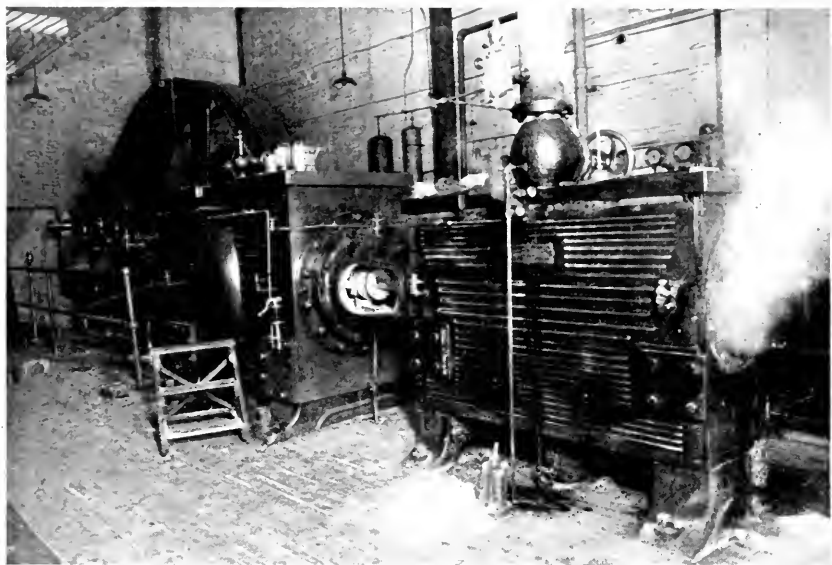
An interesting difficulty, due to peculiarities of installation, was disclosed recently following an investigation prompted by the cracking of cast iron sections of a boiler supplying steam heat to a West Virginia industrial plant and an apartment house some distance away, across a road and a creek. The return line from the apartment house to the boiler was buried in the ground for a distance of 150 ft, passing beneath both the road and the creek. This line had corroded through somewhere underground, preventing a certain amount of the condensate from returning to the boiler. Over a matter of hours, the condition resulted in low water and the consequent overheating of the boiler.

A very ingenious method was used to locate the leak. One end of the line was blanked off, and a fire hose attached to the other end. When a water pressure of 80 lb was applied to the buried line and maintained for a period of 1½ hours, water was found seeping out of the ground at the side of the creek, about 75 ft from the boiler. The buried line was uncovered at that point and two holes, each about ½" in diameter, were found to be corroded through the wall of the pipe.

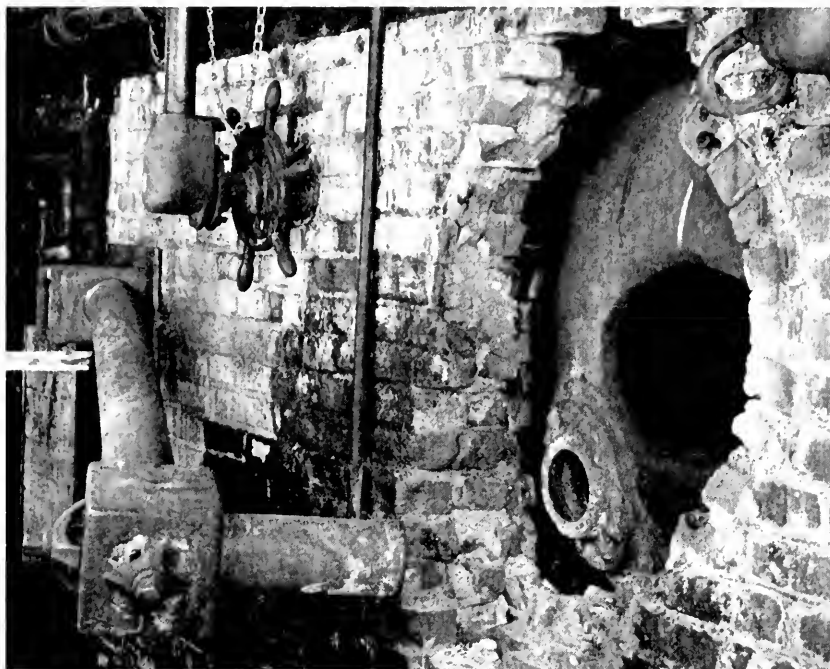
When a 5" circulating tube between the lower drum of a bent tube type boiler and a water back pulled loose from the drum on March 21, 1935, at an Indiana plant, two men who sought to leave the boiler room were fatally scalded. They were working on another boiler about 100 feet away from the circulating tube and tried to get out of the building in the confusion following the release of the steam. Besides

Circulating tube which pulled out of drum. Prompt drawing of the fire prevented serious overheating of the draining boiler.

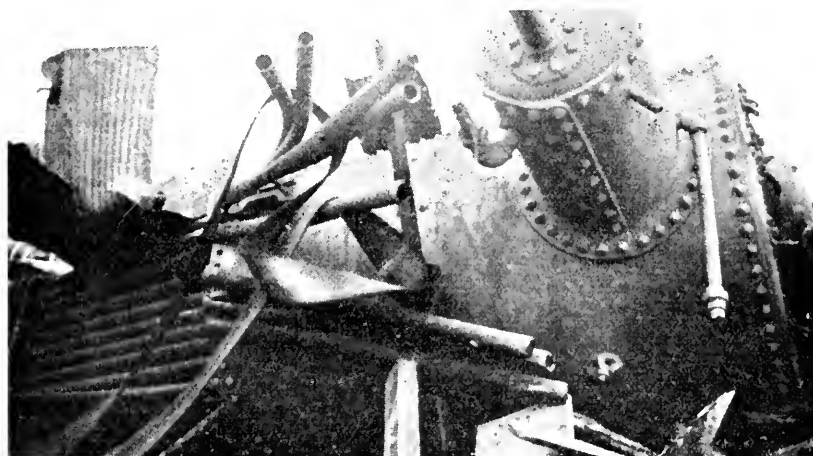
This boiler caused the wreckage in the picture at the top of the page. It is a dry back marine type and was mounted on wheels. An investigation revealed that the accident was caused by the cracking of the shell plate along the edge of the inside butt strap. The plate gave evidence that there was an old interior crack which had spread through the plate as the result of flexing action. The force of the explosion hurled the boiler about 25 feet.

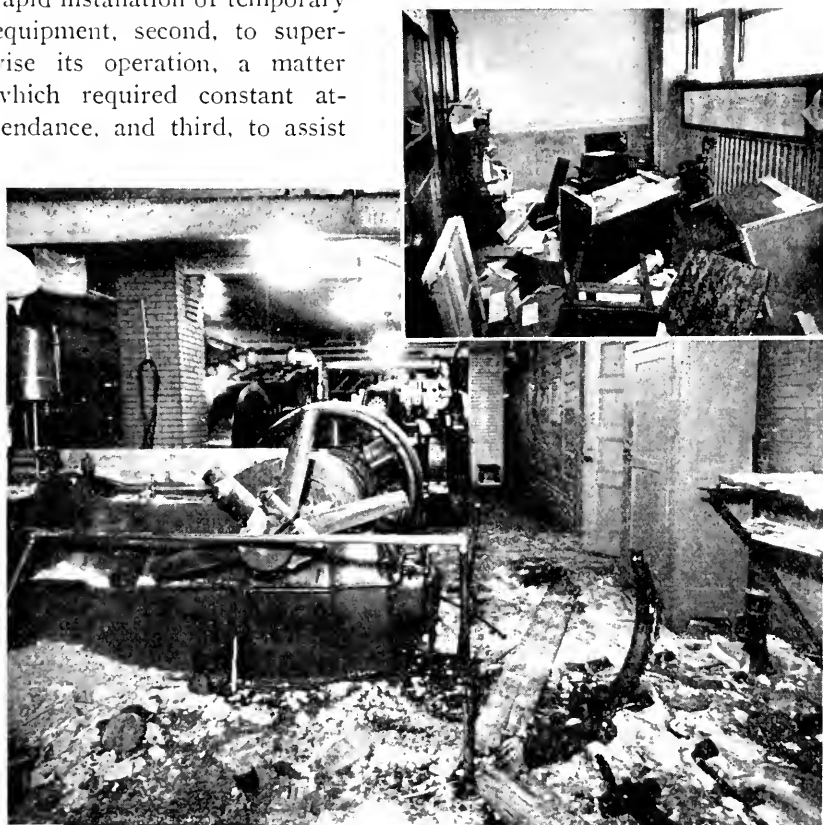
Only the spokes remain. Part of the wheel jarred the room shown above by heaving the concrete floor.

The accident occurred early in the afternoon of a Tuesday. By the following Monday a motor-generator set, an 80 hp compound wound D. C. motor, a motor-driven exciter set and necessary rheostats and switches, had been installed and paper was being manufactured. This equipment made it possible to produce about two-thirds of the average daily output, permitting the mill to fill its urgent orders.

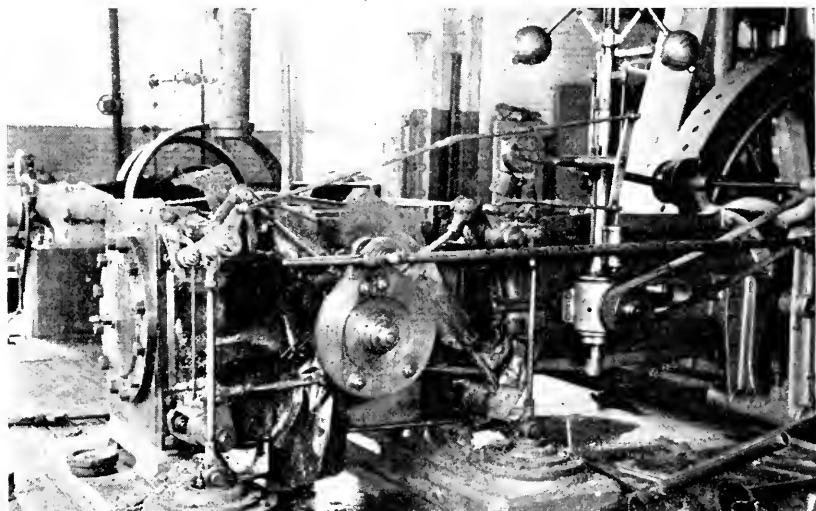
Steam Exhaust Chamber Bursts on Ammonia Compressor

AN ACCIDENT of an unusual sort, the explosion of the exhaust-steam cylinder-jacket of a Corliss-type steam-driven ammonia compressor, necessitated extensive repairs to the unit at a Pennsylvania brewery in July of this year. The operator heard an unusual sound and immediately began closing the throttle valve, but before he

Steam end of compressor after the blowing out of the exhaust-steam cylinder-jacket.

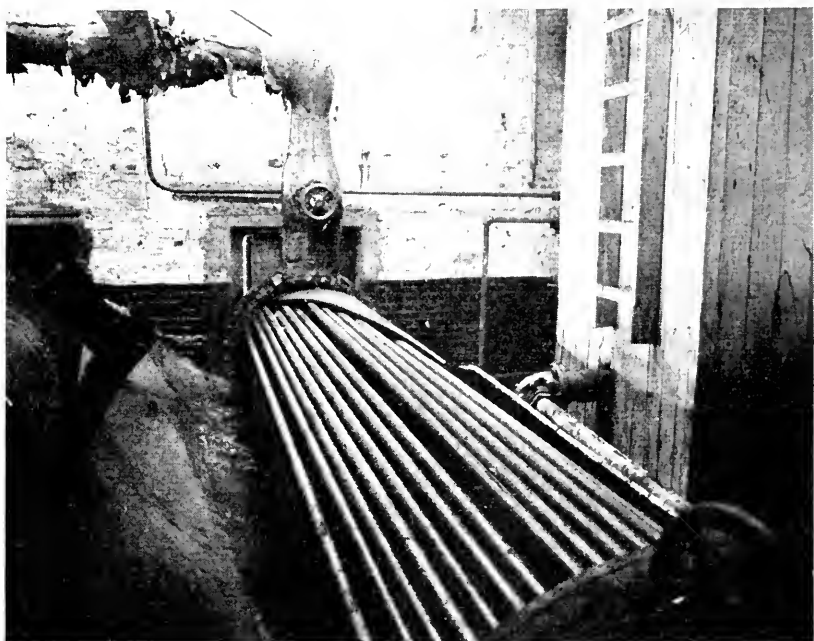
Figure 1—Caused by an unsound weld.

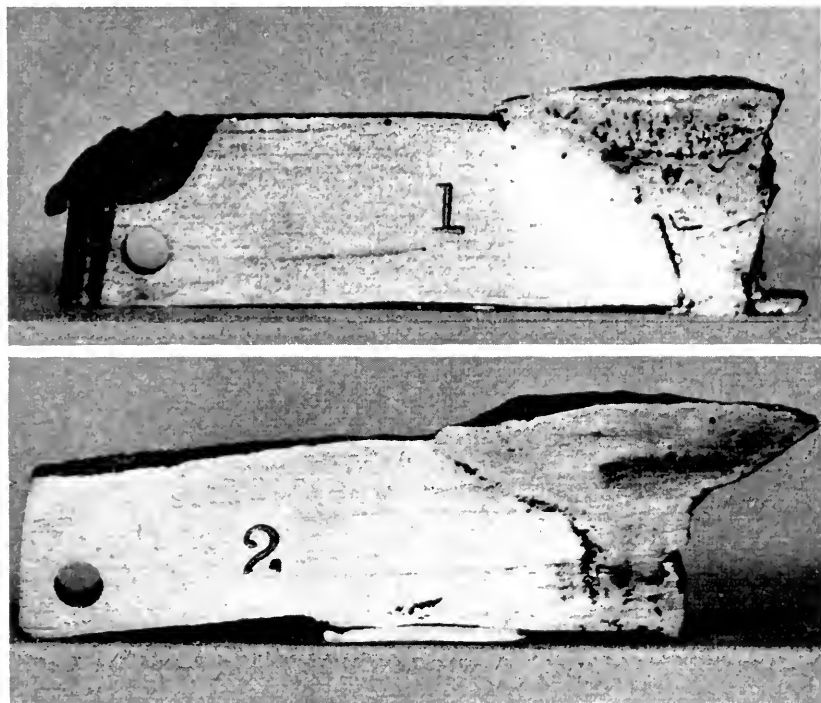
Figure 2—Etched specimens of the seams from the vessel shown in Figure 1.

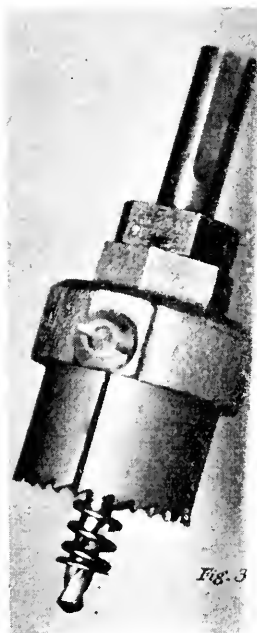
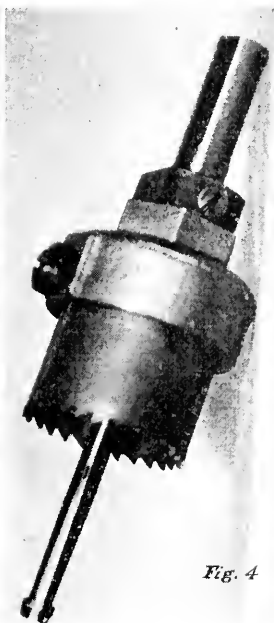
*Fig. 3**Fig. 4**Fig. 5*

Figure 3—Tool used for trepanning a plug from a welded seam.

Figure 4—Special spring and split pilot developed for trepanning tool. Figure 5—How the plug is withdrawn from the hole.

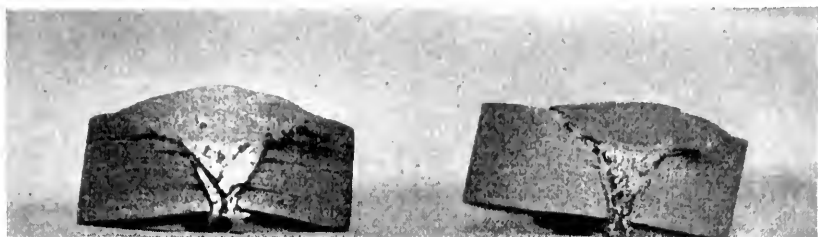
*Fig. 6**Fig. 7**Fig. 8*

Figure 6—Specimens from a fusion welded ammonia brine cooler.

Figure 7—Plugs cut from a fusion welded ammonia generator.

Figure 8—Plugs from a fusion welded soap kettle.

Some examples of plugs that have been cut from questionable vessels will be of interest. Figure 6 shows specimens removed from a fusion welded ammonia brine cooler which had been in service for several years. It is interesting to compare these plugs with the etched cross section of the weld shown in Figure 3. What might have happened if the vessel, from which the plugs were cut, had remained in service may readily be conjectured.

Figure 7 shows plugs cut from a fusion welded ammonia generator in an absorption system. After seeing these plugs, the owner decided to replace the vessel.

Figure 8 shows specimens cut from a fusion welded soap kettle. The defective seam of this vessel was rewelded by a competent operator.

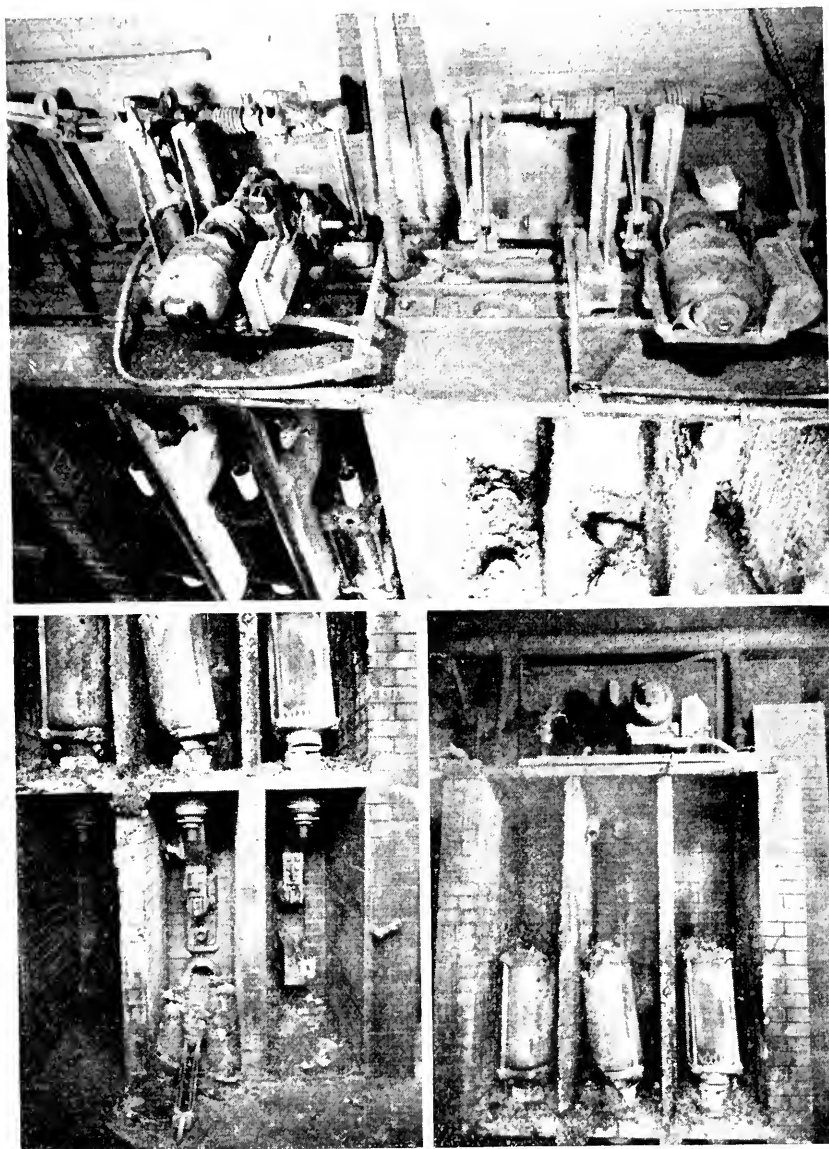
Meanwhile, the idle alternator had been given no thought. At about 4:30 A. M., smoke was seen coming out through the joints around the end bells, and the generator frame was very hot. An end bell handhole was opened to permit inspection, but the air thus admitted started heavy combustion within the machine. The fire in the generator was finally quenched by water from a hose after an attempt had been made to smother it with chemicals.

The reason for the damage to the idle alternator was not readily evident in view of the fact that the oil switch for this machine was in the open position at the time of the disturbance. On examination of the oil switch, however, it was found that heat from the arc at the other oil switch had burned through two of the wooden operating rods, thereby permitting two of the switch contacts to drop into the closed position, thus connecting the generator single phase to the power supply. The chart on the graphic wattmeter indicates that No. 1 Edison feeder oil switch tripped out from three to five minutes after the breakdown had developed into an interphase arc. The chart also shows that power was restored to the No. 1 Edison feeder approximately thirty minutes after the initial disturbance and that a load of 4,000 kw was carried for ten minutes. Unknown to the operators, this 4,000 kw was supplied single phase to the idle generator and was being transformed into heat. This generator took severe punishment as it, in effect, functioned as a single phase induction furnace. These conditions were what had pre-

case the heat was so intense that, due to unequal expansion between the outside surfaces and the internal parts of the core, the steel forging was cracked. The accident necessitated an entirely new field. The damage to the stator winding was apparently caused by radiant heat from the core of the field, as the coils indicated that they had been exposed to a very high external temperature.

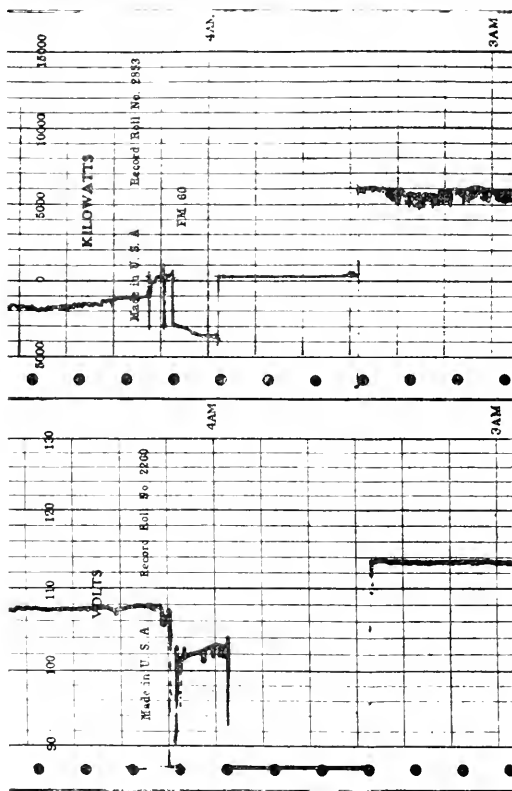
A terminal connection in the middle cell of the oil switch for the generator in operation heated and started little pin arcs. This trouble gradually grew until a sufficient arcing developed to vaporize some of the brass or copper. The arcing followed the vaporized metal and finally involved all three phases. The energy for the arc was supplied from the operating 10,000 kw alternator and the No. 1 Edison feeder. The arc-

An accident in graph form. Above—Watt-meter chart showing power conditions on No. 1 Edison feeder. The generator stopped supplying power at about 3:28 A. M. The plant was dark until 3:58 A. M., when utility power was admitted for ten minutes, burning out the idle alternator. Below—Bus voltage chart for the same period revealing why the plant's direct current motor-generator sets would not start during the 10-minute interval mentioned above.

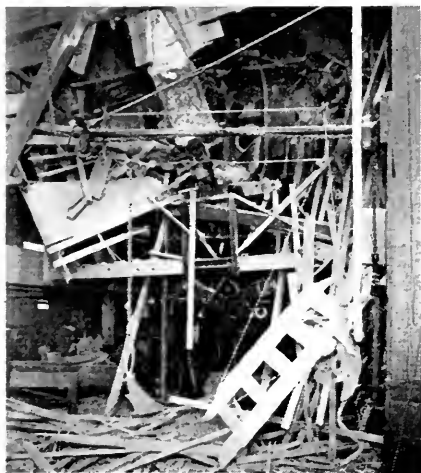
Cotton Compress Explosion

THE steam cylinder of a cotton compress exploded on November 13, 1935, in a Texas warehouse with the results shown in the accompanying illustration. The cylinder was made of cast iron and was 81" in diameter without an upper head.

Soon after the day's work had started and only 10 bales had been compressed, the cylinder exploded without warning. Fortunately neither

the operator, who was in the control booth, nor some six or seven men grouped about the machine were injured. Damage to the press, which was not covered by insurance, amounted to approximately \$5,000.

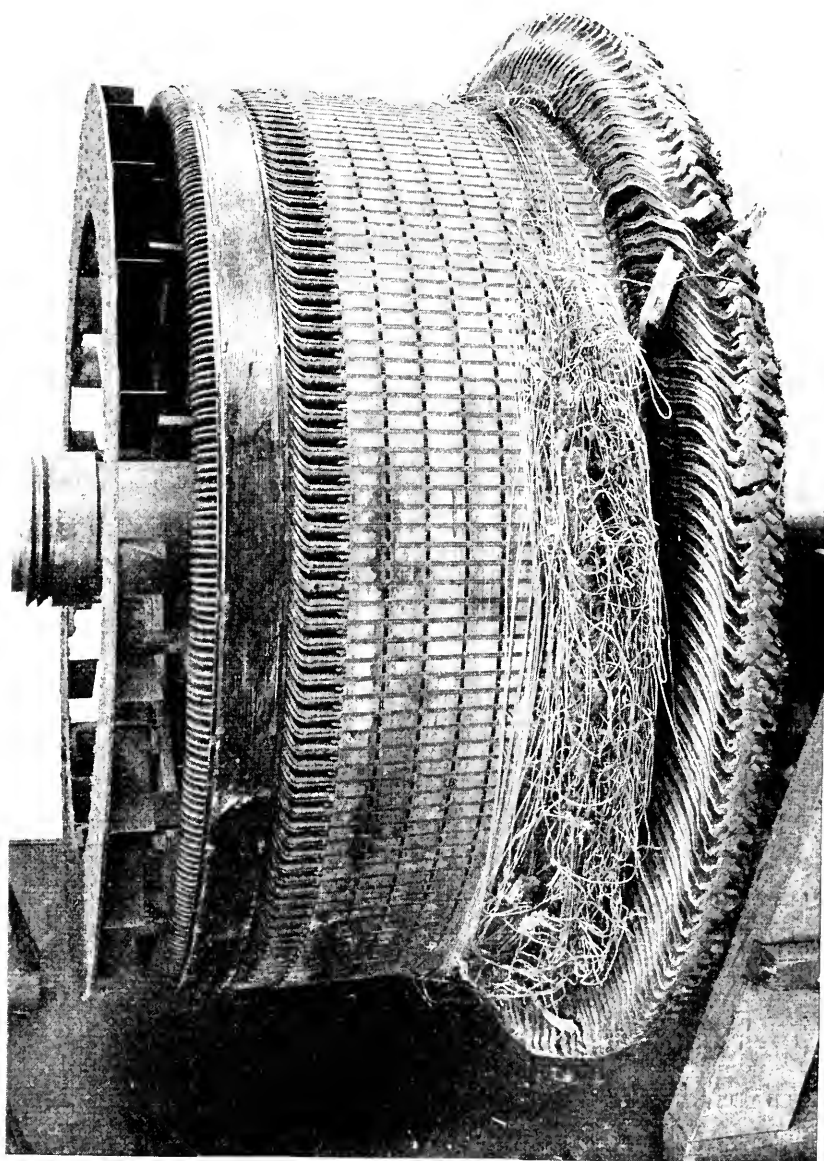
The emergency brake was automatically set on the drum. The momentum of the car probably carried the load forward a few feet, permitting the cable to sag. Freed from the upward pull, the car started down the incline and when the cable became taut, the shock loosened the grip of the brake.

Sensing what was happening, the operator decided to try to close the oil switch and make the motor operate regeneratively as an auxiliary brake. As he rushed down a flight of steps to close the circuit breaker, a terrific crash was heard and the coils in the rotor windings flew out, so damaging the machine that it was necessary to rewind both rotor and stator, make up a new ventilating fan for the collector ring end of the rotor, repair the bearing housings and the bearing supports in the housings, as well as the ring supports used for mounting the over-speed device.

The flaring out of the rotor windings, as is shown in the photograph, added to the braking effect of the slipping band brake so that the car with its heavy load slid to the bottom of the grade without developing such speed as to cause damage. It was estimated that the maximum speed of the motor was between $2\frac{1}{2}$ and 3 times normal.

900 Hp Hoist Motor Damaged Because of Overspeed.

The accident brought lumbering operations to a halt, and as use and occupancy insurance was carried, Hartford Steam Boiler undertook the direction of the repair. It was soon evident that the work would require the services of the motor manufacturer's shop in the city of Oakland, and the 3½ ton rotor and 4½ ton stator were trucked there. As copper of the proper size was not available at the repair shop, an order was telegraphed to the manufacturer's plant in the East, and a 24-hour work schedule was authorized. Shipment across the continent to the West coast was made via air express, a plan which saved between 4 and 5 days.

Both the manufacturer and the manufacturer's repair organization gave a maximum of efficient cooperation, using all possible labor and equipment on a day and night schedule. The result was that the big motor left Oakland at 4:30 P. M. September 27 and arrived at the hoist the next morning. There, all was in readiness to reinstall the motor, which was operating at 3:00 P. M. on September 28, 10 days, 3½ hours after the accident.

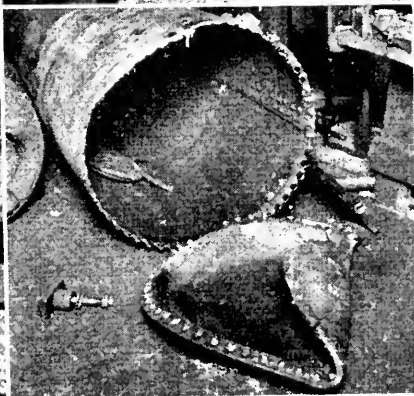
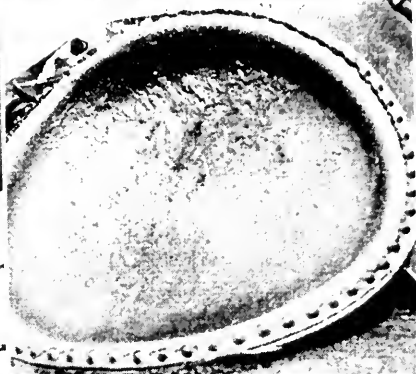
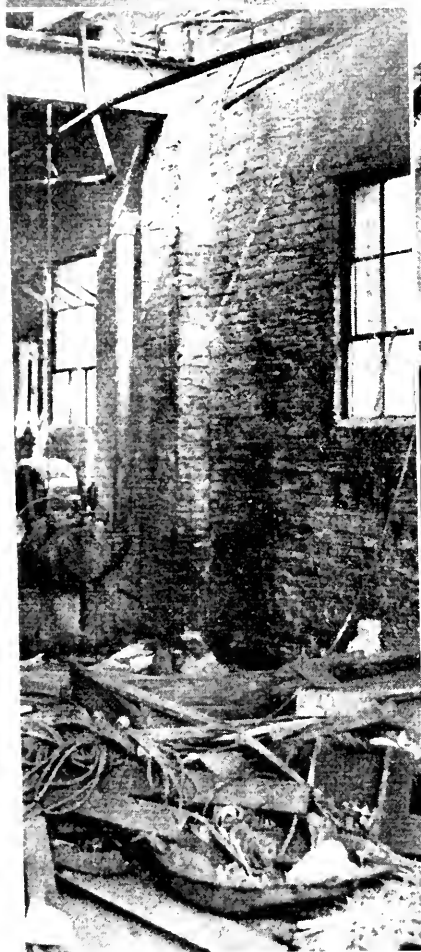
In a Maryland plant, manufacturing trailer bodies, such an explosion killed one man and injured two. The tank, to which air was supplied by a belted compressor, was 30" in diameter and 10' 4" long, with one plus and one minus head. It was made of $\frac{1}{4}$ " plate and seams were lap-riveted.

The force of the explosion caused the minus head to reverse and tear off, and the receiver hurtled upward, smashing through the roof and landing in a field about 150' from the building. Most of the windows in the building were broken, as were panes in neighboring residences; there also was damage to the compressor and piping.

Top—Side of building blown out by the explosion of the tank shown at the lower right. Upper right—Minus head reversed by oil vapor explosion. Center right—Failure caused by corrosion of rivets. Lower left—One man died and two were hurt when an air tank exploded and soared through the roof.

An Ohio scrap-iron baling plant was wrecked by the explosion of an air receiver 3' 6" by 7' with a minus head $\frac{3}{8}$ " thick. Again it was the reversal of the minus head because of an oil vapor explosion which tore open the tank. In this case, just prior to the blast, flame was noted issuing from the safety valve. Employees also reported that the safety valve had been operating intermittently and that the discharge pipe from the compressor was red hot. The air compressor was definitely in need of extensive repairs, and as its large oil feeders were filled at least twice a day, it may be assumed that an abnormally large amount of lubricant was used. The head of the tank is shown in the accompanying illustration.

In the prevention of such oil vapor explosions, proper maintenance of the compressor is essential. It is important to use the correct lubricant, to see that discharge valves are kept in good condition, and to have a clean water jacket. Leaky discharge valves on the compressors probably were responsible for the temperature rise leading to at least one and perhaps all of the above accidents. (For a discussion of air compressor explosions because of combustible oil vapor see THE LOCOMOTIVE, July, 1934, Page 66).

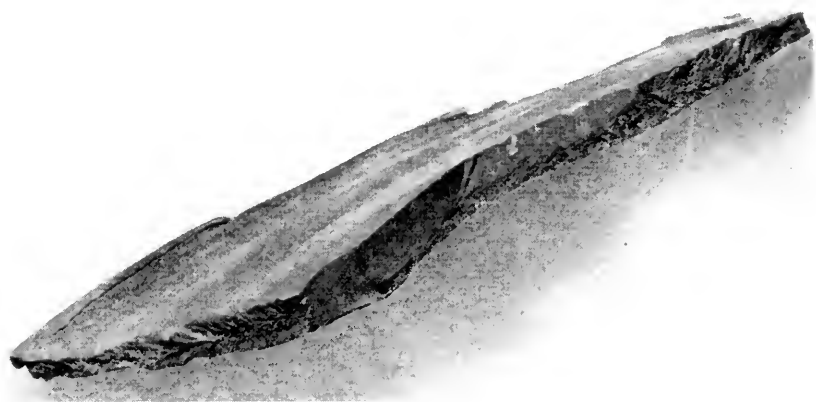
A 3,500 kw impulse turbine driving a generator at a Southern cotton mill was destroyed when the 3rd stage disc exploded because of

Section of turbine disc which exploded because of a fatigue crack.

a progressive crack. Replacement of the machine, which was about 12 years old, involved an estimated cost of more than \$100,000. The explosion took place while the emergency governor was being tested. When the machine reached 8 per cent above its operating speed, vibration suddenly increased and the accident occurred. The steam end was wrecked, there was serious damage to the generator because of the distortion of its shaft and the rubbing of the field against the stator, the foundation was cracked in several places, and extensive damage was suffered in the condenser room. As the severed section of the wheel did not go through the steel turbine casing, there was no loss of life or serious injury to the operators, although the jolt knocked a helper off his feet. It was felt that, although the testing of the emergency governor may have hastened the time of the ultimate failure, the accident would have occurred at some later date under ordinary

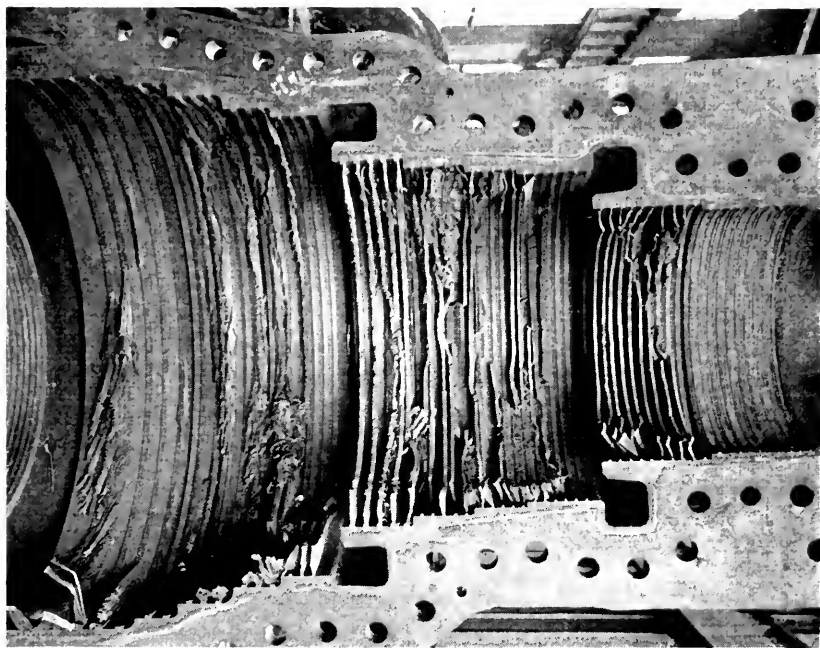
An accident to a 6,000 kw reaction type steam turbine-alternator at an Ohio steel mill resulted in the stripping of all but one row of blades on the spindle and the stripping or bending of all of the stationary blades. This, with other damage, caused a loss estimated at approximately \$40,000.

Mashed rows of reaction blading after temperature strains had contracted the casing and rotor unevenly.

However, because the 6,000 kw unit was on the line with the other turbines, the current reversed and operated the generator as a motor, causing the turbine to continue to revolve, a condition which the graphic voltage chart showed lasted about 3 minutes before the engineer cut the switch, it having been necessary for him to run from the floor below, after a whistle signal sounded. Because the governor shut off all steam to the turbine, the vacuum from the condenser immediately extended to the head end of the cylinder and the temperature dropped from about 458° to 115° F. The subsequent contracting of the metal was sufficient to move the front end of the cylinder toward the exhaust where the casing was anchored. On account of its bulk, the spindle did not contract as rapidly with the result that the low pressure water impeller was pulled against the generator side of the impeller casing. The movement also caused the high pressure dummy packing to rub against the revolving dummy strip which, in conjunction with the rubbing of the low pressure impeller, caused a severe vibration of the unit. It was this vibration which led to the serious damaging of the turbine, the damage, besides the stripping of the blades, including the breaking of the governor casting, the cracking of the bearing casting and of the cast iron exhaust casing, and the distortion of the shaft.

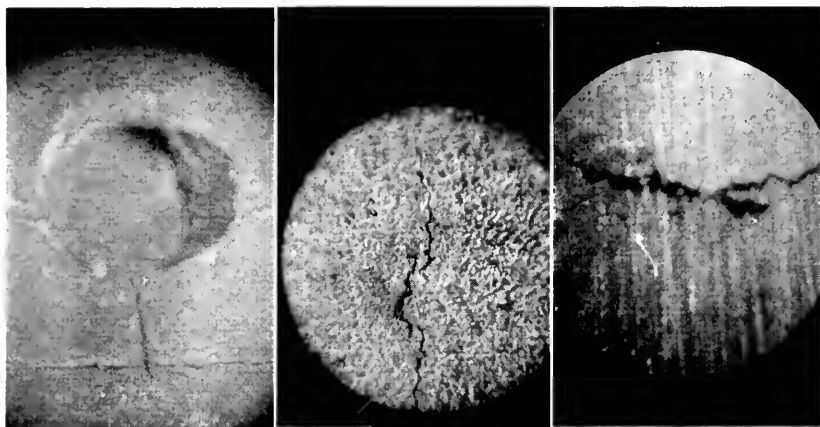
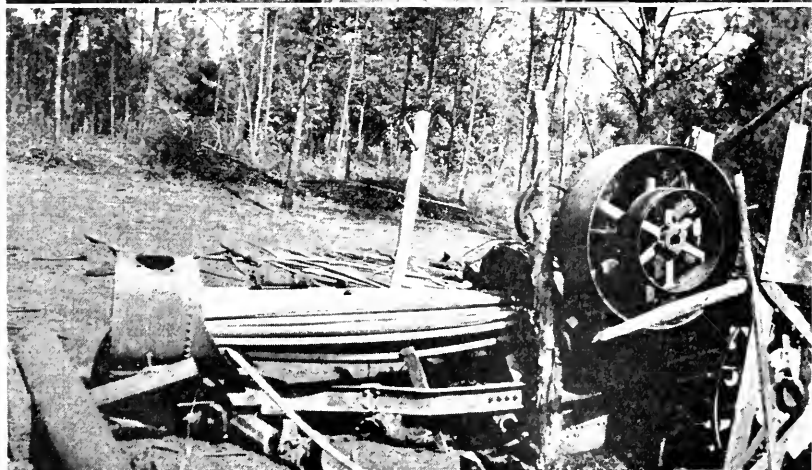
ON inspecting a power boiler at a Mid-West plant, the insurance of which Hartford Steam Boiler was recently asked to take over, the inspector discovered a leaky seam which showed evidence of having been caulked repeatedly in a fruitless effort to make it tight. He noticed, too, that several new rivets had been driven in the seam. Inquiry developed the information that the seam had been giving trouble for some time and that rivet heads had been found broken off

Left—crack which caused the leakage. Center—the crack at the left as it appeared in the rivet hole. Right—characteristic embrittlement cracks with which the plate was affected.

from time to time. As these symptoms pointed to the probable existence of serious distress, the inspector took steps to verify his suspicion. His investigation led to the discovery of a case of plate embrittlement which had progressed to a dangerous degree.

The boiler was of the bent tube type, and of medium size. Its seams were of double-riveted lap construction. The leakage came from a crack in the plate under the lap of the longitudinal seam and since it did not extend beyond the caulking edge of the seam, its presence would not have been suspected by one not conversant with this type of failure. Each time the seam had been recaulked the defect had progressed and further leakage had been increasingly difficult to stop. When the drum was examined in detail, the seam was found to be seriously weakened

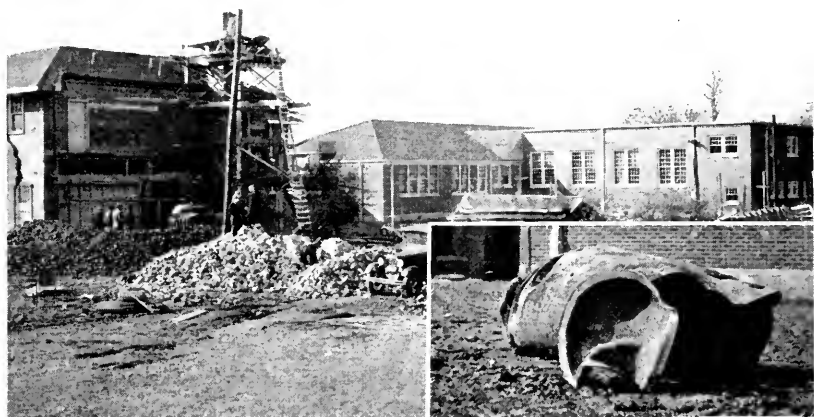
A YOUNG music teacher was killed when a hot water supply tank exploded in the boiler room of the consolidated school at Horn Lake, Mississippi, on the morning of February 17. Fortunately a recess saved the children. The sixth grade had left the music room, situated over the boiler room, barely five minutes before the explosion, and the school quartet was due there for rehearsal in another

Wreckage of music room and boiler room after explosion.

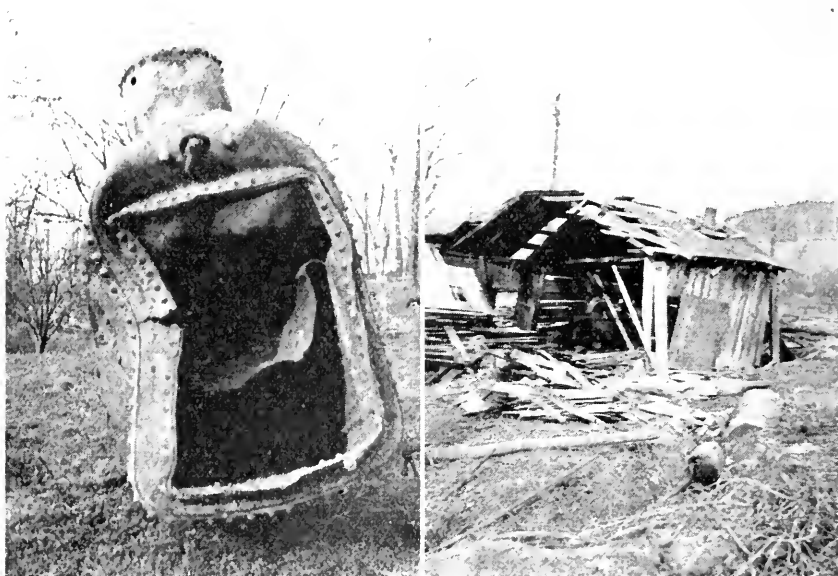
An old crack in the rear course of a 36" diameter horizontal tubular boiler, used at a Southern sawmill, in April brought about the result shown in the accompanying photograph. The vessel was projected 60

feet from its setting. Although the setting was made of mud and stones and was scattered over a wide area, only one of the nine men about the mill at the time was injured. A pair of mules escaped injury when the shell landed immediately in front of them. The 20-year-old boiler had been idle for two years. It had been fired up only a few hours when the shell tore along the crack which extended for almost

the full length of the 6' course and nearly through the plate. The photograph shows the inside of the butt strap and the line of failure adjacent to the top edge of the strap. The crack bore evidence of having existed for a long time and the metal adjacent to it was reported to be nearly as brittle as cast iron. The accident was attributed to inferior metal and excess pressure over a prolonged period.

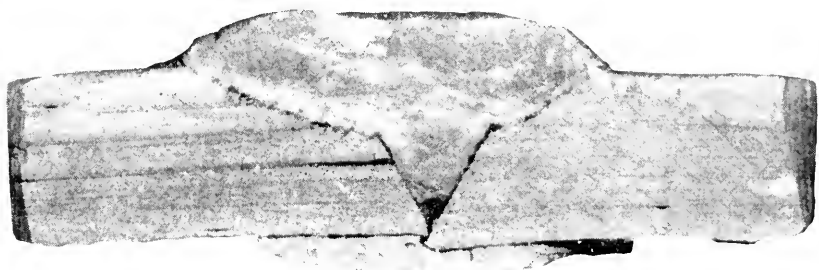
Figure 5

Figure 5. Illustration of an extreme case of lack of fusion in the lower half of the welding groove, slag on the fusion line and almost entire lack of fusion of reinforcement on the underside.

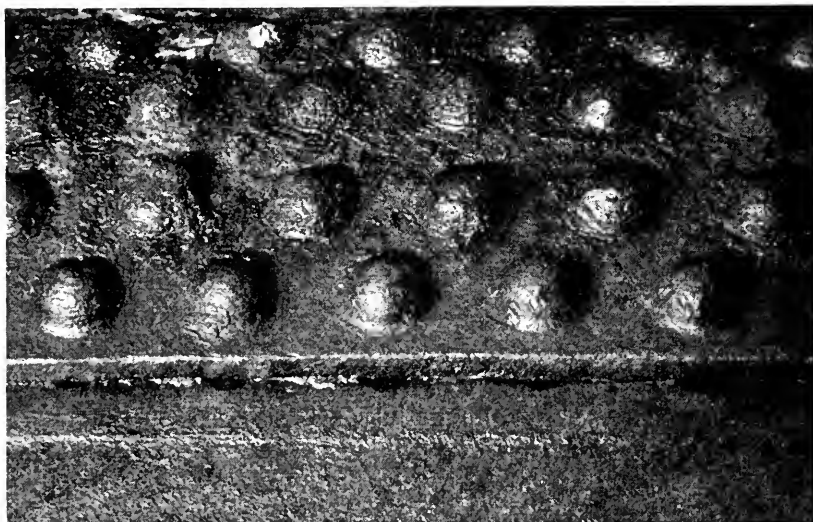
Figure 1—Seam which pulled apart for 6 feet after embrittlement had developed to a serious extent.

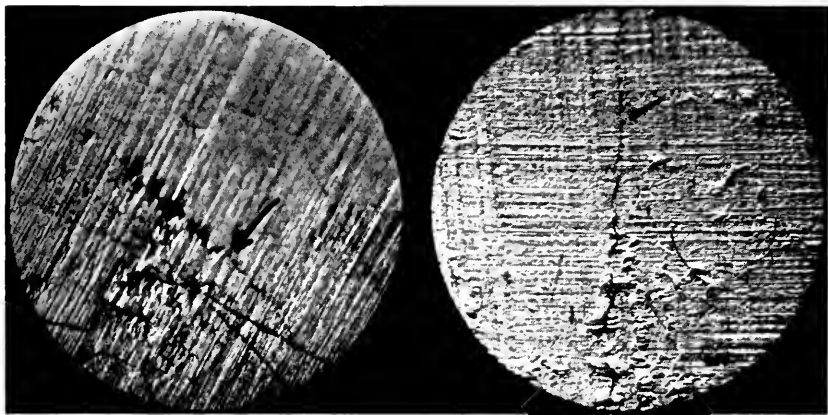
Figure 2—Characteristic embrittlement in another boiler of the same battery as the affected vessel.
